**Flood Control Project Maintenance
Levee Inspections**

Fall 2019 Levee Maintenance Deficiency Summary Report

Sacramento River Basin

**Flood Control Project Maintenance
Levee Inspections****LMA District Cover Sheet****Fall 2019 Levee Inspection Results****Reclamation District No. 0787 Fair**

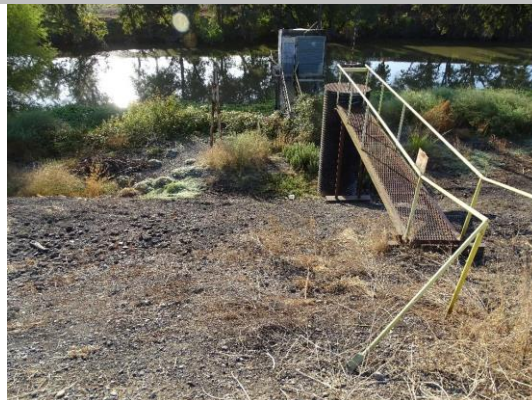
Photo 1 of 3 : UCIP_FA_2019_55350_81594.jpg

Comment Code						
Inspector Comment						
DS_ID:22892						
FS_ID:55350						
EP_NO: 9392						
Repair Type: Non-Urgent						
Crossing Status: Found						
UCIP Comments: 09/30/2019 Crossing creates a levee slope depression near LS toe. Top of a concrete headwall shows up in the depression. (O.Yakimov - DWR UCIP)Dense vegetation limits the inspector's visibility to identify signs of pipe failure (leaks) along the slope. Recommend removing vegetation along pipe alignment to conduct proper inspection of structure.						
FIELD_STRUCT_DESC: 36-inch concrete irrigation pipe through the levee, 17 feet below the crown. Slide gate in 36-inch standpipe on the waterside (WS). 24-inch pipe from standpipe to pump house mounted on steel structure in channel. (36-inch pipe authorized under Automatic Board Order (ABO) issued as Permit No. 9392, 1974 - River Garden Farms; pump structure and 24-inch steel pipe authorized under Permit No. 3878, 1962-River Farms Company of California). [Additional Reference(s): DWR Levee Logs, 1990]

Pump house and walkway on river's edge

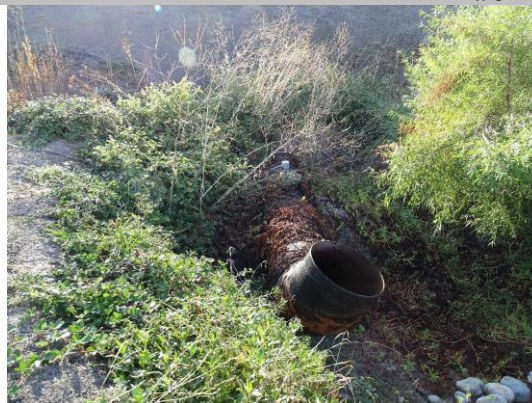
Photo 2 of 3 : UCIP_FA_2019_55350_81593.jpg

Pipe outlet in irrigation ditch on LS

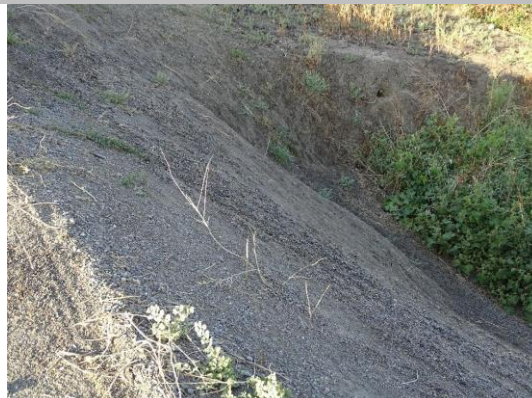
Photo 3 of 3 : UCIP_FA_2019_55350_81595.jpg

Comment Code						
Inspector Comment						
DS_ID:22892 FS_ID:55350 EP_NO: 9392 Repair Type: Non-Urgent Crossing Status: Found UCIP Comments: 09/30/2019 Crossing creates a levee slope depression near LS toe. Top of a concrete headwall shows up in the depresiion. (O.Yakimov - DWR UCIP)Dense vegetation limits the inspector's visibility to identify signs of pipe failure (leaks) along the slope. Recommend removing vegetation along pipe alignment to conduct proper inspection of structure. FIELD_STRUCT_DESC: 36-inch concrete irrigation pipe through the levee, 17 feet below the crown. Slide gate in 36-inch standpipe on the waterside (WS). 24-inch pipe from standpipe to pump house mounted on steel structure in channel. (36-inch pipe authorized under Automatic Board Order (ABO) issued as Permit No. 9392, 1974 - River Garden Farms; pump structure and 24-inch steel pipe authorized under Permit No. 3878, 1962-River Farms Company of California). [Additional Reference(s): DWR Levee Logs, 1990] FS Date: 9/30/2019 2:50:15 PM

Depression on LS slope

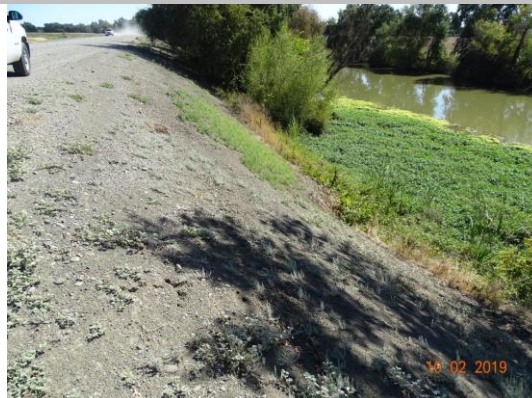
Photo 1 of 6 : FA_2019_RD0787_212_4_20191003_00019.jpg

LM Start	0.73	Rating **	M	Issue No.	4
LM End	0.86	Issue Type +	Ma	Location *	WS
Category	Supplemental			GPS Latitude/Longitude	
				Start	End
Item	2017 Storm Damage			38.795769 °	38.796340 °
				-121.736798 °	-121.738956 °
DWR ID	RD 787-01				
Comment Code					
Inspector Comment					
Levee Evaluation Comments					
Description:					
Site ID No:182					
Site Designation:RD 787-01					
Repair Type: Erosion					
Rating:Area of Concern					
Field Date:7/18/2017					
Notes:

View of the steep waterside slope at LM 0.86. Fall 2019.

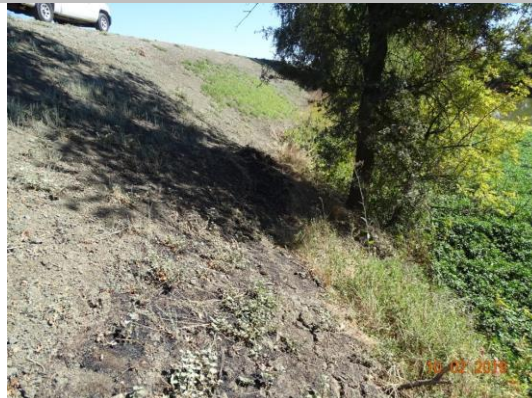
Photo 2 of 6 : FA_2019_RD0787_212_4_20191003_00020.jpg

View of the waterside slope bak caving from the adjacent waterside berm at LM 0.86. Fall 2019.

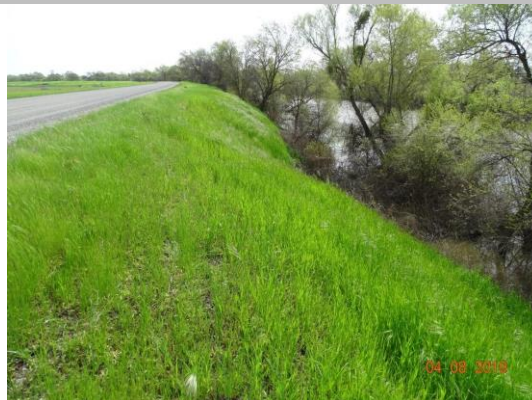
Photo 3 of 6 : FA_2019_RD0787_212_4_20190829_00001.jpg

View of bank caving on the waterside slope, facing downstream. Spring 2019.

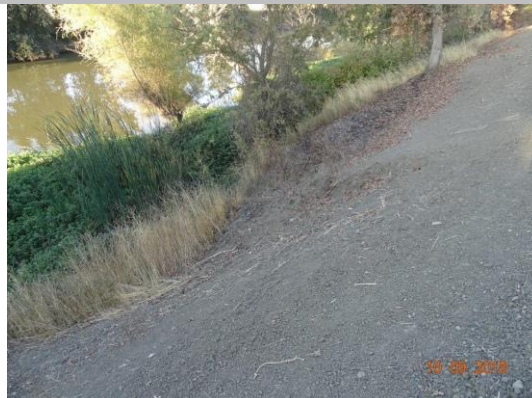
Photo 1 of 3 : FA_2019_RD0787_212_9_20190829_00005.jpg

LM Start	0.73	Rating **	A/W	Issue No.	9
LM End	0.73	Issue Type +	Ma	Location *	WS
Category	Earthen Levee			GPS Latitude/Longitude	
				Start	End
Item	Erosion / Bank Caving			38.795814 °	38.795814 °
				-121.736799 °	-121.736799 °
DWR ID	DWR_RD0787_01_s_2017_9				
Comment Code					
E1 : Note and monitor erosion site.					
Inspector Comment					
Erosion on the waterside slope from 2017 storms. Recommend monitoring.

View of erosion on the waterside slope, facing upstream. Fall 2018.

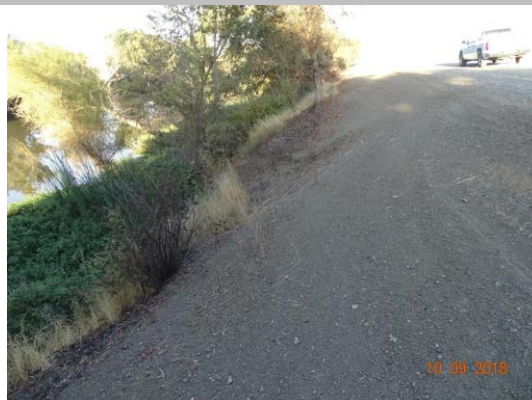
Photo 2 of 3 : FA_2019_RD0787_212_9_20190829_00006.jpg

Additional view of erosion, facing upstream. Fall 2018.

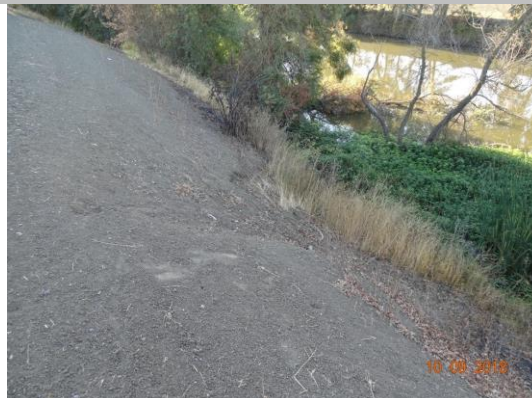
Photo 3 of 3 : FA_2019_RD0787_212_9_20190829_00007.jpg

View of erosion, facing downstream. Fall 2018.

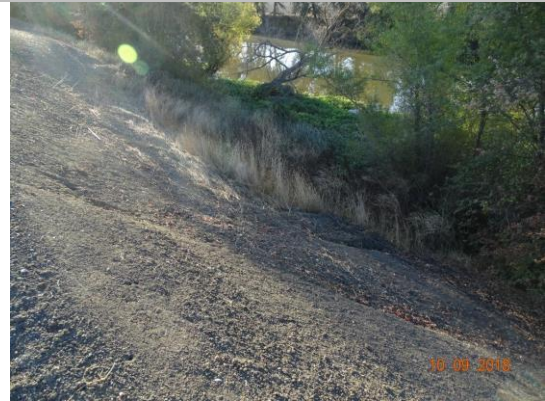
View of erosion on the waterside slope, facing downstream. Fall 2018.

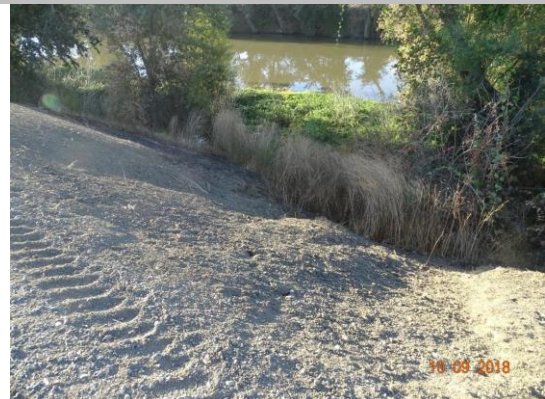
LM Start	0.77	Rating **	A/W	Issue No.	15
LM End	0.77	Issue Type +	Ma	Location *	WS
Category	Earthen Levee			GPS Latitude/Longitude	
				Start	End
Item	Erosion / Bank Caving			38.795996 °	38.795996 °
				-121.737493 °	-121.737493 °
DWR ID	DWR_RD0787_01_f_2018_15				
Comment Code					
E1 : Note and monitor erosion site.					
Inspector Comment					
Erosion on the waterside slope from 2017 storms. Recommend monitoring.

View of erosion on the waterside slope, facing downstream. Fall 2018.

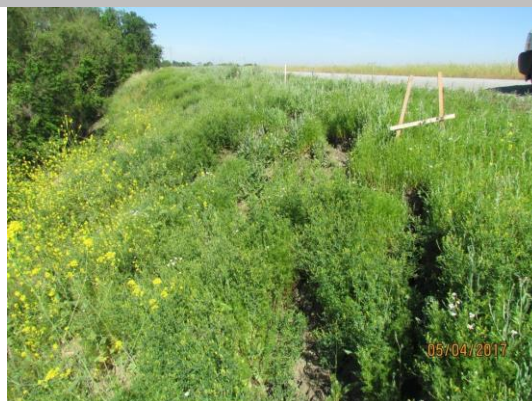
Photo 2 of 2 : FA_2019_RD0787_212_15_20190829_00013.jpg

LM Start	0.77	Rating **	A/W	Issue No.	15 (cont)	
LM End	0.77	Issue Type +	Ma	Location *	WS	
Category	Earthen Levee			GPS Latitude/Longitude		
				Start		End
Item	Erosion / Bank Caving			38.795996 °	38.795996 °	
				-121.737493 °	-121.737493 °	
DWR ID	DWR_RD0787_01_f_2018_15					
Comment Code						
E1 : Note and monitor erosion site.						
Inspector Comment						
Erosion on the waterside slope from 2017 storms. Recommend monitoring.

View of sloughing on waterside slope. Spring 2017.

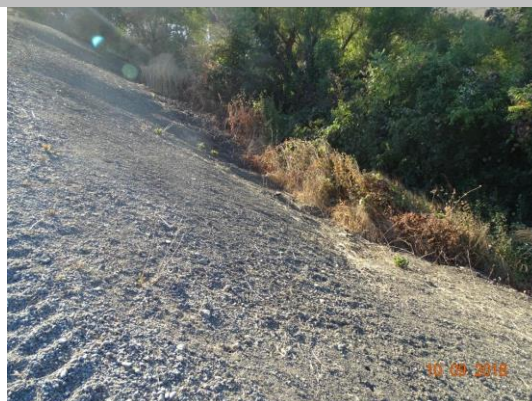
Photo 1 of 1 : FA_2019_RD0787_212_16_20190829_00014.jpg

LM Start	0.78	Rating **	A/W	Issue No.	16
LM End	0.78	Issue Type +	Ma	Location *	WS
Category	Earthen Levee			GPS Latitude/Longitude	
				Start	End
Item	Erosion / Bank Caving			38.796042 °	38.796042 °
				-121.737661 °	-121.737661 °
DWR ID	DWR_RD0787_01_s_2017_16				
Comment Code					
E1 : Note and monitor erosion site.					
Inspector Comment					
Erosion on the waterside slope from 2017 storms. Recommend monitoring.

View of erosion on the waterside slope, facing downstream. Fall 2018.

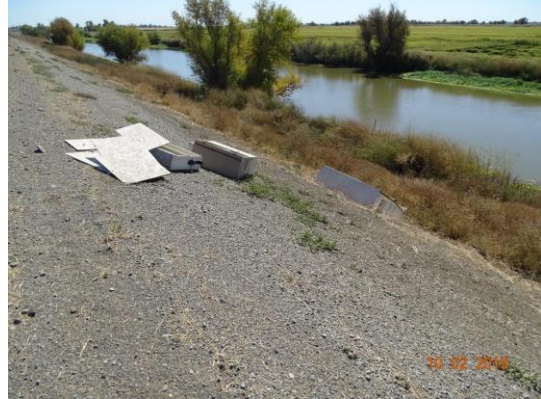
Photo 1 of 1 : FA_2019_RD0787_212_11_20191003_00021.jpg

LM Start	3.38	Rating **	M	Issue No.	11
LM End	3.38	Issue Type +	Ma	Location *	WS
Category	Earthen Levee			GPS Latitude/Longitude	
				Start	End
Item	Encroachments			38.814734 °	38.814734 °
				-121.778979 °	-121.778979 °
DWR ID	DWR_RD0787_01_f_2019_11				
Comment Code					
DE : Debris					
Inspector Comment					
A cabinet was dumped on the waterside slope.

View of the debris on the waterside slope. Fall 2019.
